Re: Middle Ground Shoal Platform, Natural Gas Pipeline Release

Middle Ground Shoal Gas Leak Sampling and Monitoring Plan Summary Report

Sampling Period #7 ending 05/02/2017

Weekly Report #7

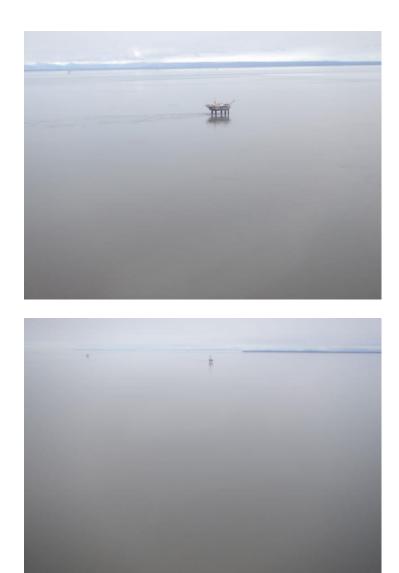
Photograph Log

Photos were taken the vicinity of the leak with a view of Platform A. Flight circles are approximately 0.5 miles apart. The still water has been conducive to detecting flight or dive movements of wildlife.

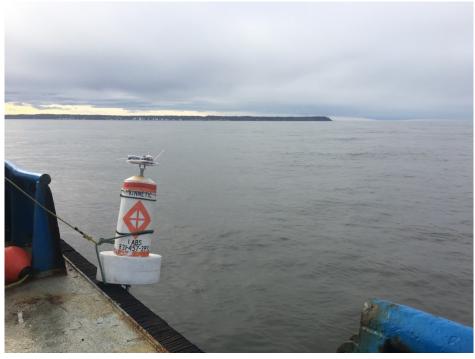
Typical conditions during Week 7. There was no sea ice and relatively flat seas. Buoy is seen here tied to the boat during Drift 1. Bubbles were not observed on the water surface near the MRP at any point during the day.

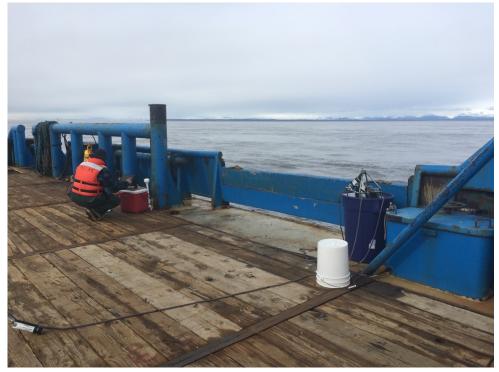
Photo 2: CTD and mid-level sensors were stored in a container of seawater collected from Cook Inlet near the project site to keep them as close to insitu conditions as possible between drifts.

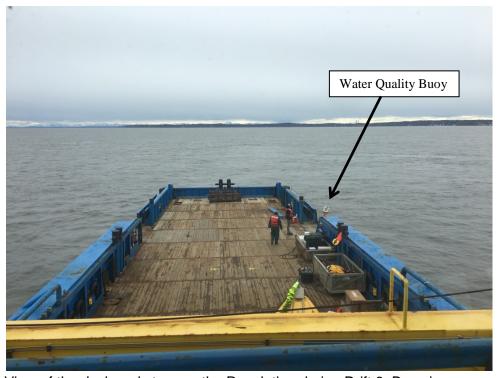
Photo 3:

View of the deck and stern on the Resolution during Drift 3. Buoy is attached to the side of the boat on right. Conditions remained ice-free with waves less than 1 foot. Winds were approximately 10 knots out of the North.
